### Revisiting stress-corrosion cracking and hydrogen embrittlement in 7xxx-Al alloys at

#### the near-atomic-scale

#### Abstract

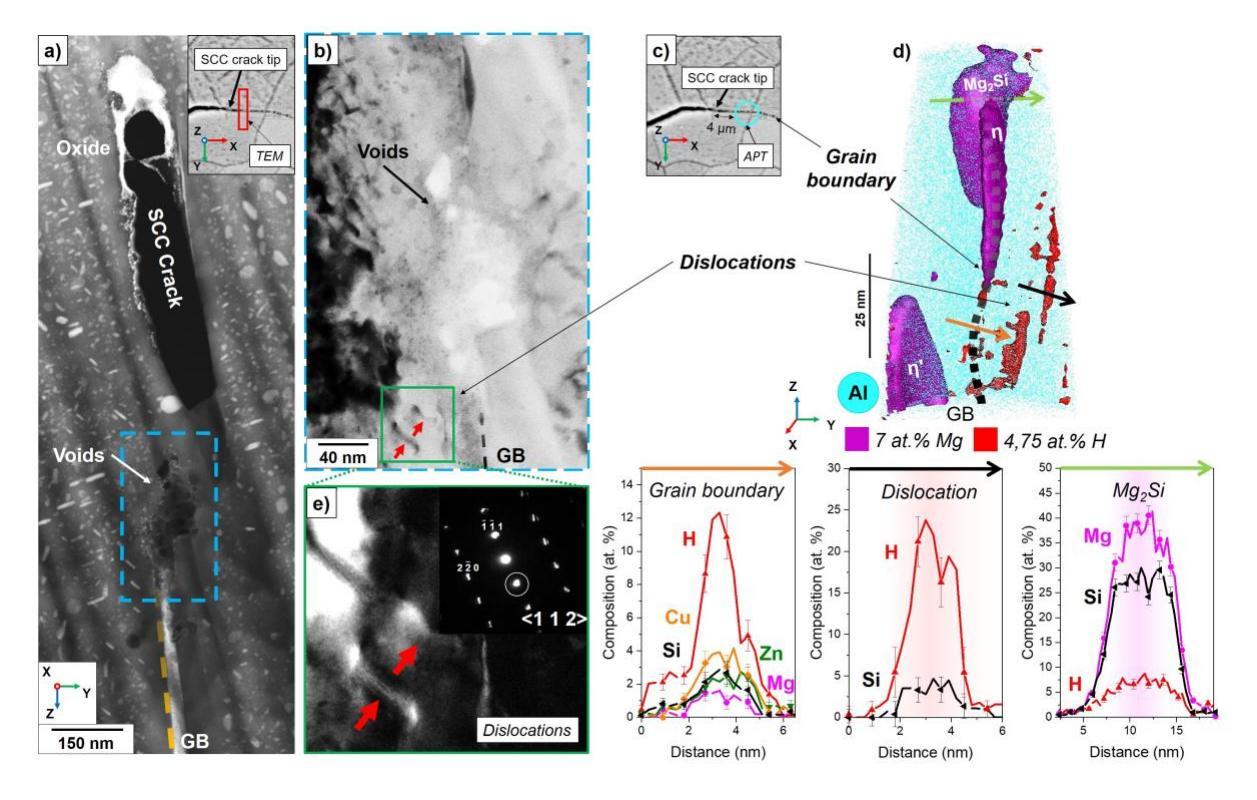
Figure 1. H effects on deformation behaviour near the SCC crack. a) STEM image of the crack tip region revealing the presence of oxide and void-like structures. b) TEM BF image showing dislocations near the crack. c) Schematic of the APT sample location with respect to the crack tip. d) APT reconstruction of the GB 4µm ahead of the crack showing the presence of dislocations with H and Si segregation. 1D Composition profiles across the GB, the dislocation and the Mg<sub>2</sub>Si particle, respectively measured along the arrows shown in the APT reconstruction. The error bars correspond to the standard deviation within each of the bins in the profile. e) DF image corresponding to the (111) diffraction spot of the dislocations imaged in b). Note that the SEM micrograph in c) and inset in a) is indicative of the analysis location. The results displayed herein were obtained from different cracks tips.

We performed an industry standard DCB crack growth test to study the SCC behaviour of the alloy 7449-T7651. We investigated the crack tip region using (S)TEM. The crack is intergranular and displays void-like features (Figure 1a), suggested by Lynch <sup>9</sup> to be one of the crack propagating mechanisms. Energy-dispersive X-ray spectroscopy (EDS) confirms the presence of an oxide at the crack and within the voids, and the matrix adjacent to the crack oxide is devoid of precipitation (Figure S3 and Figure S4). The selected area electron diffraction pattern from the corroded crack indicates that the oxide is amorphous (Figure S5). Near the void-like features, we observed an array of dislocations (Figure 1b), indicative of plasticity, sitting on (111) planes, as confirmed by dark field TEM (inset Figure 1b).

APT analysis was performed approx. 4 µm ahead of a crack tip (Figure 1c). The dataset contains a GB with  $\eta/\eta'$ -phase precipitates as well as Mg<sub>2</sub>Si particles. The red set of iso-surfaces delineates regions of high H composition that form a planar array of elongated features (Figure 1d) typically associated with segregation to dislocations <sup>42–44</sup>. Based on atom probe crystallographic analysis, as outlined in ref. <sup>45</sup>, we confirmed that these features lie on a (111) plane, as expected for dislocations in the face-centred cubic Al-matrix, thereby supporting the hypothesis. The segregated H reaches locally near 20 at. %, along with approx. 4 at. % Si. H is also found segregated to the grain boundary and trapped within the Mg<sub>2</sub>Si particle sitting at the boundary. This is in line with recent reports of H segregation to grain boundaries in a 7xxx Al-alloy <sup>16</sup>. The observed segregation to the dislocations could thus be caused by the shearing through Mg<sub>2</sub>Si particles, and both Si and H being dragged by, or subject to pipe diffusion along the dislocation connecting regions of different chemical potential <sup>46–48</sup>. H measurements by APT are notoriously challenging, because of the presence of H from the residual gas of the ultrahigh vacuum chamber <sup>49</sup>. The reliability of our measurements is further discussed below.

Our results provide evidence for H absorption and segregation to dislocations and GBs during SCC in 7xxx aluminium alloys. HE caused by the ingress of H ahead of the crack tip generally causes a "brittle" fracture surface appearance and CAMs <sup>55</sup>. The embrittling effect of H had been so far been proven indirectly<sup>56</sup>. In-situ TEM experiments have shown that H promotes slip planarity, enhanced dislocation glide and a decreased flow stress <sup>57,58</sup>. H transport by dislocations was already proposed by Albrecht et al. <sup>59</sup> in 1982, but had not been directly measured in aluminium alloys, especially during SCC. We provide here (Figure 1d) the first evidence of co-localisation of H and dislocation cores and promoting slip localization and/or localised transport. H segregating to dislocation cores and promoting slip localization and H transport forms the ground of HELP, i.e. one of the prevalent HE models <sup>14,24,60</sup>, and our observations strongly suggest it that it is active during SCC. As samples are over 3 years old, H must have been deeply trapped by the dislocations, consistent with previous reports <sup>15</sup>.

In addition, we present evidence of H segregating to grain boundaries ahead of the crack during SCC (Figure 1d), suggesting that HEDE could be contributing to the crack progression, reducing the grain boundary cohesion based on the mechanism proposed by Zhao et al. <sup>16</sup>. Since H was detected along the GB, within an Mg<sub>2</sub>Si intermetallic particle and at dislocations in the matrix near the grain boundary 4µm ahead of the crack, H diffusion through the grain boundary must have occurred during the crack propagating or as the cracked surface oxidised.

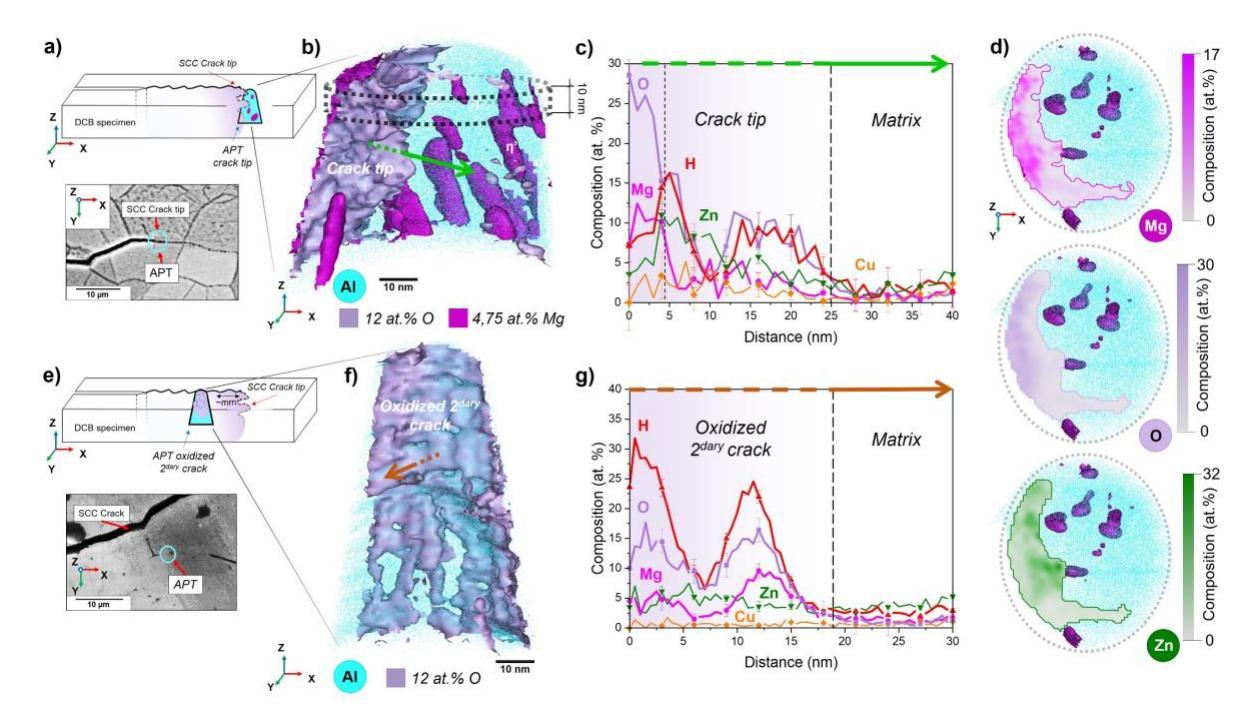
Figure 2. Crack corrosion behaviour during SCC. a) Schematic of a DCB sample showing the APT crack tip sample location and orientation. b) APT reconstruction of the crack tip of an SCC crack. c) 1D composition profile across the oxide-matrix interface showing the oxide composition, measured within a 10 nm (Ø) cylinder along the arrow in b). d) 2D composition maps, obtained from a 10 nm slice, showing the 2D elemental distribution of Mg, O and Zn in the oxide within the dotted-line slice shown in b). e) Schematic of a DCB sample showing the APT secondary crack sample location and orientation. f) APT reconstruction of an oxidized secondary crack displaying the complex oxide morphology and absence of precipitation. g) 1D composition profile across the oxide-matrix interface, measured within a 10 nm (Ø) cylinder along the arrow in f). The error bars correspond to the standard deviation within each of the bins in the composition profiles shown.

We targeted the tip of an SCC crack for specimen preparation along the main propagating crack in the DCB sample (Figure 2a). Analysis of the desorption pattern (Figure S6) formed through the APT dataset (Figure 2b) provided sufficient crystallographic information to determine the existence of two grains and thus of a GB within the reconstruction. We therefore assumed that we captured the tip of the actual propagating crack, as SCC cracks are known to propagate almost exclusively following an intergranular mode in Al-alloys <sup>5</sup>. However, we could not locate the GB within the dataset, as no clear evidence of segregated solutes could be found, and there was a microfracture <sup>50</sup> during the data acquisition that could lead to a loss of information specifically in the GB region.

An iso-composition surface with an arbitrary threshold of 12 at.% O highlights the oxide-matrix interface, which exhibits a very complex, rough morphology (Figure 2b). Figure 2c plots the atomic ratios through the interface, along the suspected crack propagation direction. A two-layer structure appears, with first a ~5 nm zone enriched in Mg and O, followed by a region with increased Zn and lower in O and Mg. O/H increase again further ahead, but Mg and Zn do not show increased levels. The formation of an Mg-rich oxide film in aluminium alloys was suggested by Green et. al. <sup>51</sup> and reported experimentally <sup>20,22</sup>. The oxide film is also found to be hydrated, which is in line with previous observations <sup>5,20,21</sup>. Levels of Cl of up to 6 at%, not included in the profiles for clarity, are also incorporated in the oxide film, as expected <sup>6</sup>.

Two-dimensional compositional maps from the top of the reconstructed APT dataset as indicated in Figure 2d, and displayed top-down, highlight the inhomogeneity of the oxide and complement Figure 2c. The enrichment of Mg and O is coincident, while Zn and Cu (Figure S7) appear to be accumulated at the oxide-metal interface. This suggests that Mg is being preferentially oxidized and that dealloying is occurring during corrosion of the freshly cracked surface. An Mg-rich and Zn-poor oxide and a Zn-rich, Mg-poor adjacent region is consistent with previous reports on oxidized  $\eta$ -phase precipitates <sup>30,52,53</sup>.

We then performed APT analyses several mm in the wake of the crack tip, along an oxidized secondary crack (Figure 2e), in order to reveal the solute distribution long after the crack has passed. The tomographic reconstruction in Figure 2f also evidences a complex morphology of the interface between the metallic matrix and the oxidised crack. A composition profile perpendicular to the oxide/metal interface (Figure 2g) shows the highly inhomogeneous oxide composition, with H levels reaching up to 30 at.% in the film, and with O/H peaks coinciding with Mg peaks. Conversely, Zn and Cu display no partitioning. The adjacent matrix is devoid of precipitates, as observed also by STEM-EDS (Figure 1 and Figure S3). This motivated an analysis of the composition of the  $\eta$ -phase precipitates around the crack tip (Figure 3a) that reveals a lower solute content than expected. The Mg content decreases down to 13 at.% and Zn levels to 20 at.% within the precipitates, on average leaner in solute compared to the reference composition reported in Figure S1**Error! Reference source not found.**b. The behaviour of Cu is similar to Mg and Zn, with Cu levels going from 7,3 at.% in the reference measurements (**Error! Reference source not found.**Figure S1b) to 2,7 at.% in the  $\eta$ -phase precipitates around the crack tip (Figure 3a).

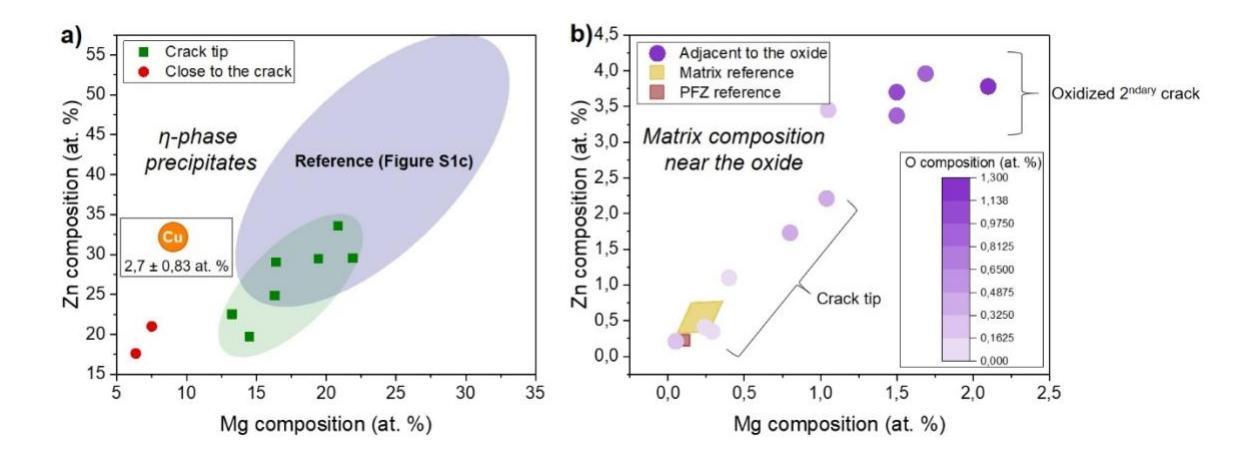
Figure 3. Matrix and  $\eta$ -phase precipitate compositional differences near the oxide a)  $\eta$ -phase precipitate composition around the crack tip and very close to the crack compared with reference values from Figure S1c. The composition of  $\eta$ -phase precipitates captured close to the crack, within 1 µm, in another dataset are also added to the analysis. Cu average composition in the  $\eta$ -phase precipitates at the crack tip and close to the crack is also reported, also showing a marked decrease in Cu content with respect to reference values from Figure S1c. The error values reported for Cu correspond to the standard deviation of all measurements; b) matrix composition around the crack tip and adjacent to the oxidized secondary crack compared with reference values from Figure S1b. Matrix O levels are also displayed at each data point. Please refer to Figure S2b for error values for O measurements.

The precipitates' dissolution leads to a significant increase in the matrix composition (Figure 3b), up to tenfold across different locations around the crack tip with respect to the undeformed reference (Figure S1a). This is also observed in the matrix adjacent to the oxidized secondary crack (Figure 3b and Table 1), where the composition is close to the alloy's nominal composition (Table 2), except for Mg, which has leached to the oxide layer. The matrix composition in the vicinity of the crack tip bridges the gap between the near-crack region and the reference data, hinting at a transient precipitate dissolution process (Figure 3b). The variation in the matrix compositions is notably higher than in the reference measurements and no correlation between the solute enrichment and the distance to the captured oxides could be established. We also quantified the O dissolved in the matrix which, to a first approximation, scales with the increasing matrix solute content, as reported by the colour change of the symbols in Figure 3b, and is far above the expected content <sup>54</sup>.

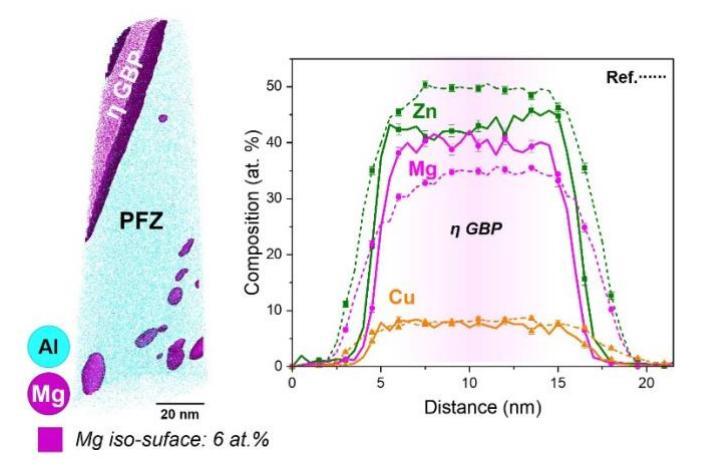
Figure 4. Grain boundary ahead of the crack tip. APT reconstruction of the grain boundary ahead of the crack, showing a  $\eta$ -phase grain boundary precipitate with an Mg composition increased with respect to the 33 at.% dictated by the stoichiometry of the Mg(Zn, Cu, Al)<sub>2</sub> phase. The error bars correspond to the standard deviation within each of the bins in the profile.

APT analyses near or at the grain boundary ahead of the crack yielded more evidence of the dynamic behaviour of the microstructure during SCC. APT analysis of a  $\eta$ -phase grain boundary precipitate located approx. 2 µm ahead of the crack shows an increased Mg concentration with respect to the expected stoichiometry of Mg(Zn,Cu,Al)<sub>2</sub>. The analysis reveals 38 at.% Mg, 46 at.% Zn, and 7 at.% Cu on average through the whole precipitate, but with 40 at. % Mg being reached locally (Figure 4). This difference is significant based on the standard deviations for a GBP measured in the reference sample (Table 1).

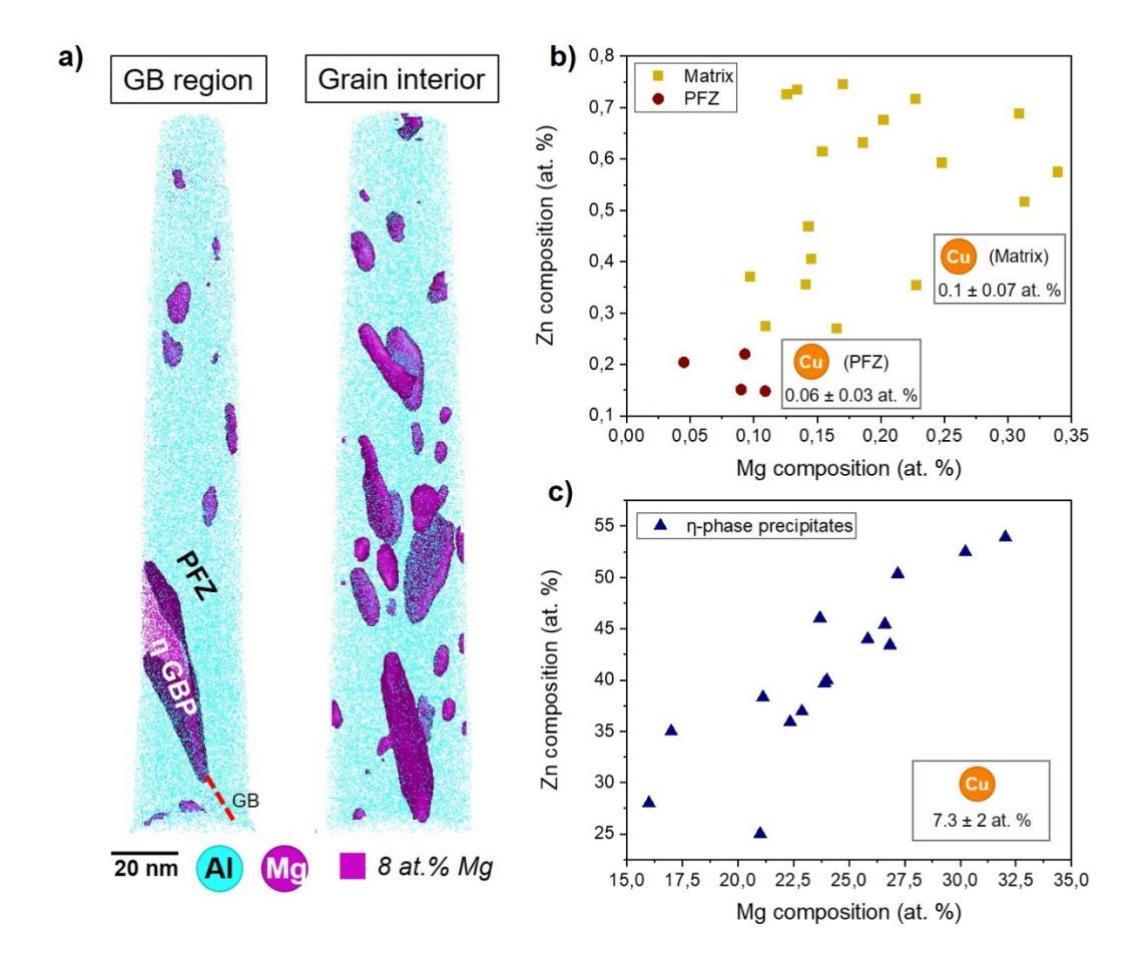
Figure S1. Sample characterization, APT reconstructions of the grain boundary and the grain interior away from the crack. a) Solute matrix composition from 4 datasets and PFZ reference compositions from the dataset shown above; b)  $\eta$ -phase precipitates reference compositions taken from the grain interior from 3 datasets and the near GB region from the dataset shown above. Only plate shaped precipitates were analysed. The error values reported for Cu correspond to the standard deviation of all measurements.

APT analyses of the commercial aluminium alloy 7449-T7651 from the GB and the grain interior away from the crack including,  $\eta$ -phase precipitates, matrix and PFZ are displayed in Figure S1. Features across multiple datasets show spread in their compositions, as plotted in Figure S1b-c. Mg and Zn levels within the  $\eta$ -phase precipitates from the grain interior and the near GB region display a linear relationship, with Mg ranging from 15 to 32 at.%, and Zn from 25 to 54 at.%. In turn, matrix and PFZ solute compositions exhibit an array of possible values. The mean Cu value for each of the features of interest are shown in Figure S1b-c. The average composition values of the matrix, PFZ and the  $\eta$ -phase GBP are reported in Table 1.

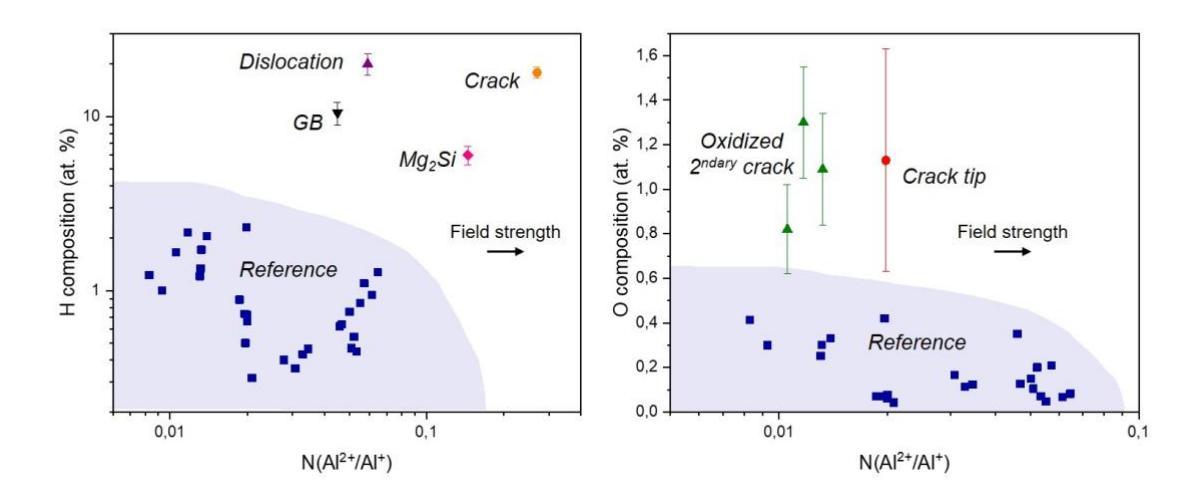
Figure S2. Reliability of H/O measurements in APT. a) Hydrogen composition within the oxide in the secondary crack (Figure 2f) and at the dislocation (**Error! Reference source not found.**d) plotted against field strength during the APT experiments, showing an increase with respect to reference values at similar field strengths. b) Oxygen composition in the matrix adjacent to the crack tip (Figure 2b) and the oxidized 2<sup>ndary</sup> crack (Figure 2f), also showing increased levels. Values from the matrix from several datasets are included as reference.

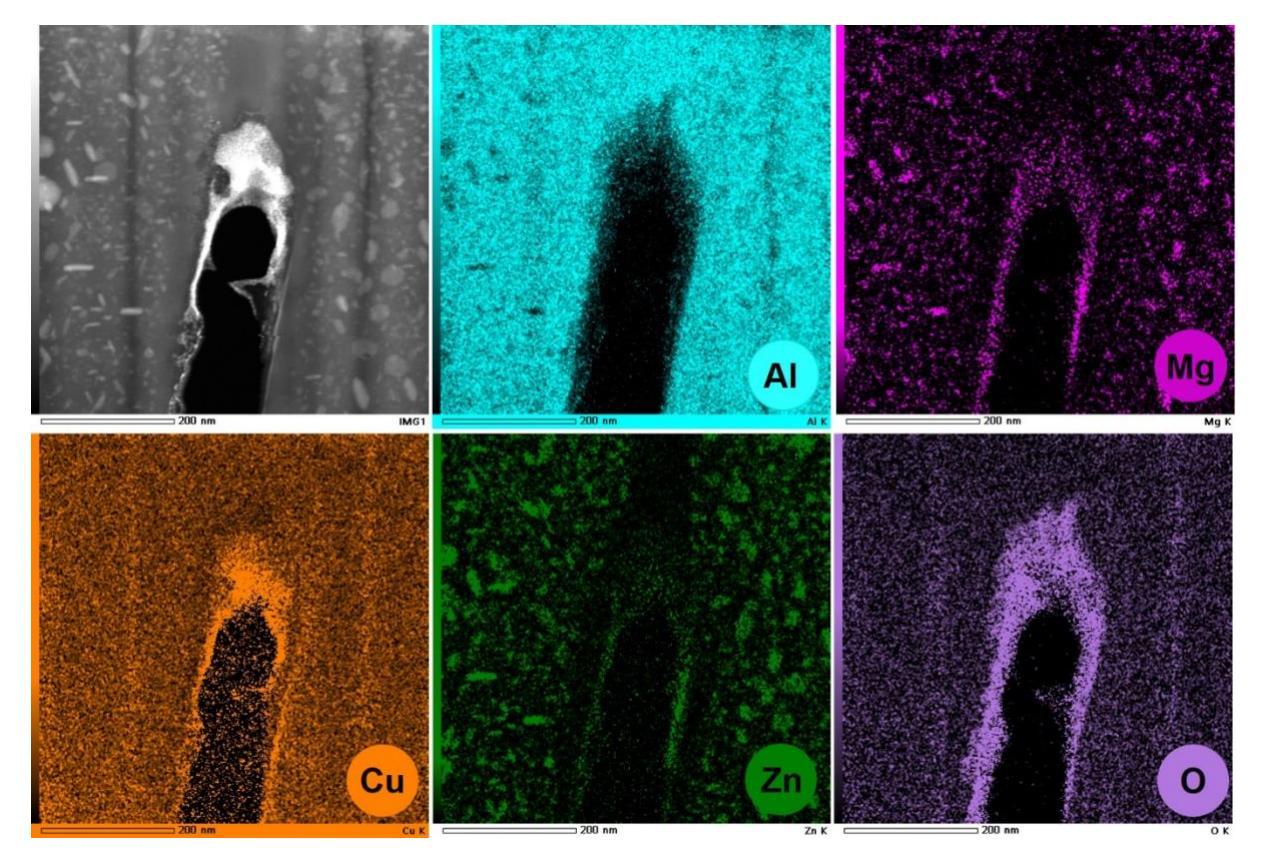
Figure S3. EDS maps of the SCC crack shown in Figure 1a

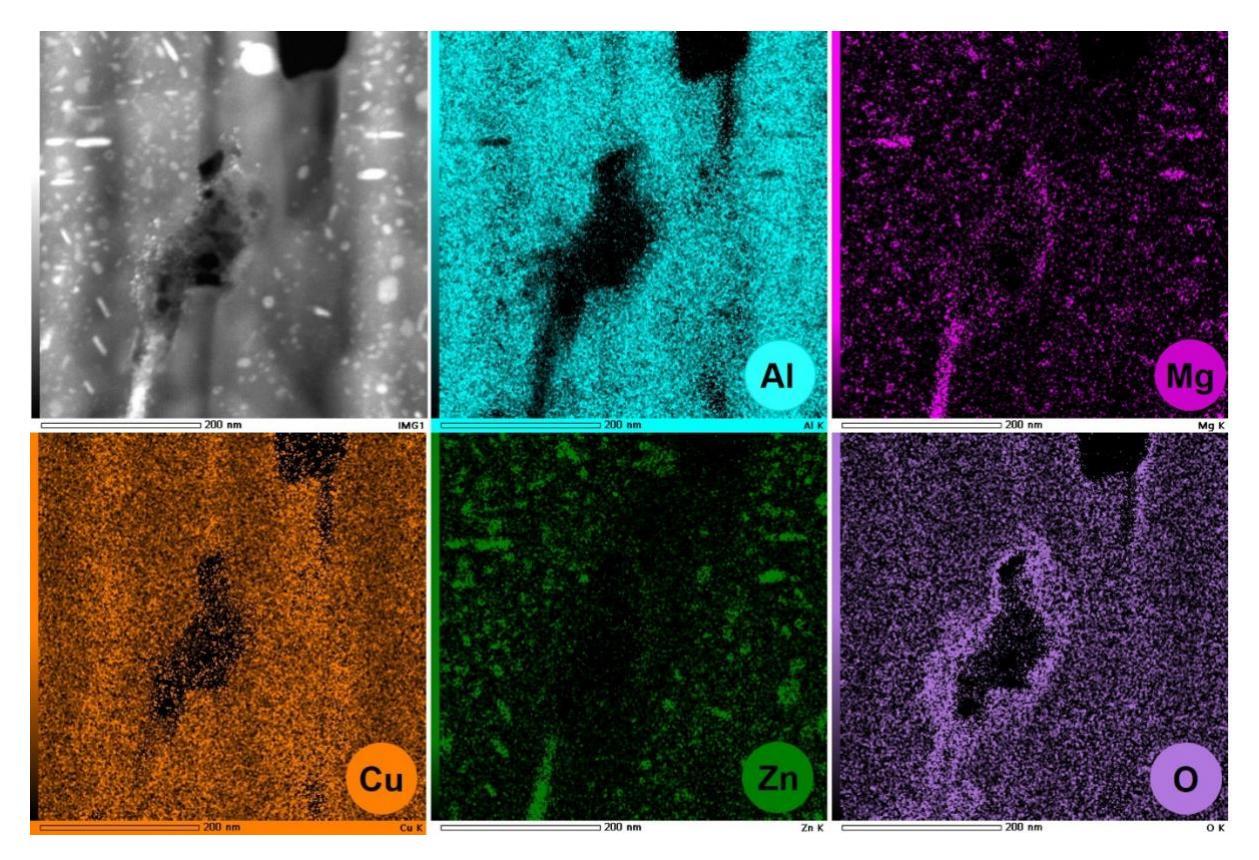
Figure S4. EDS maps of the void-like features shown in Figure 1a

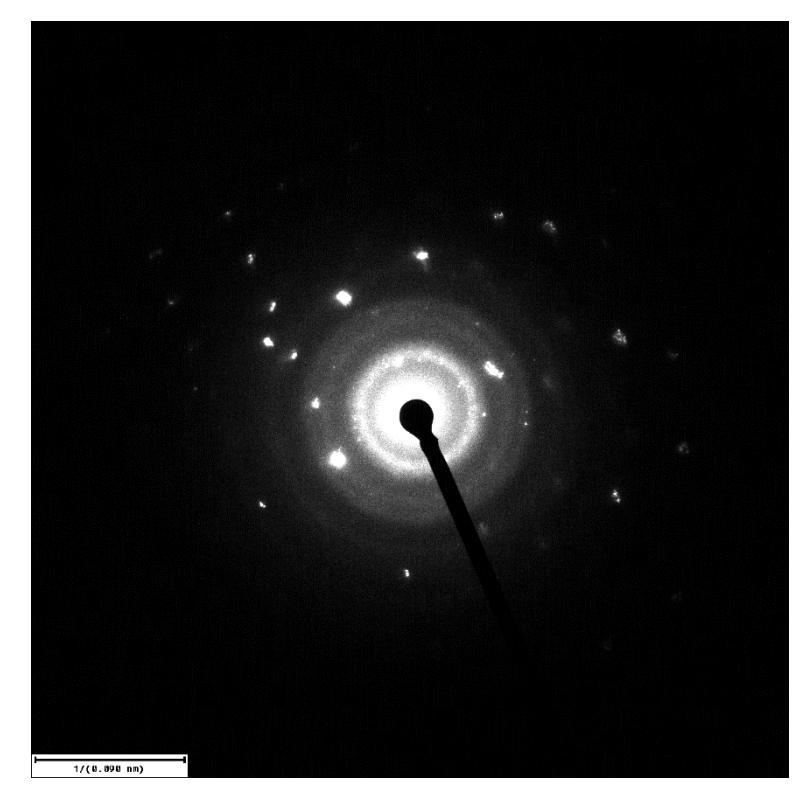
Figure S5. Selected area electron diffraction pattern from the oxide region in Figure 1a

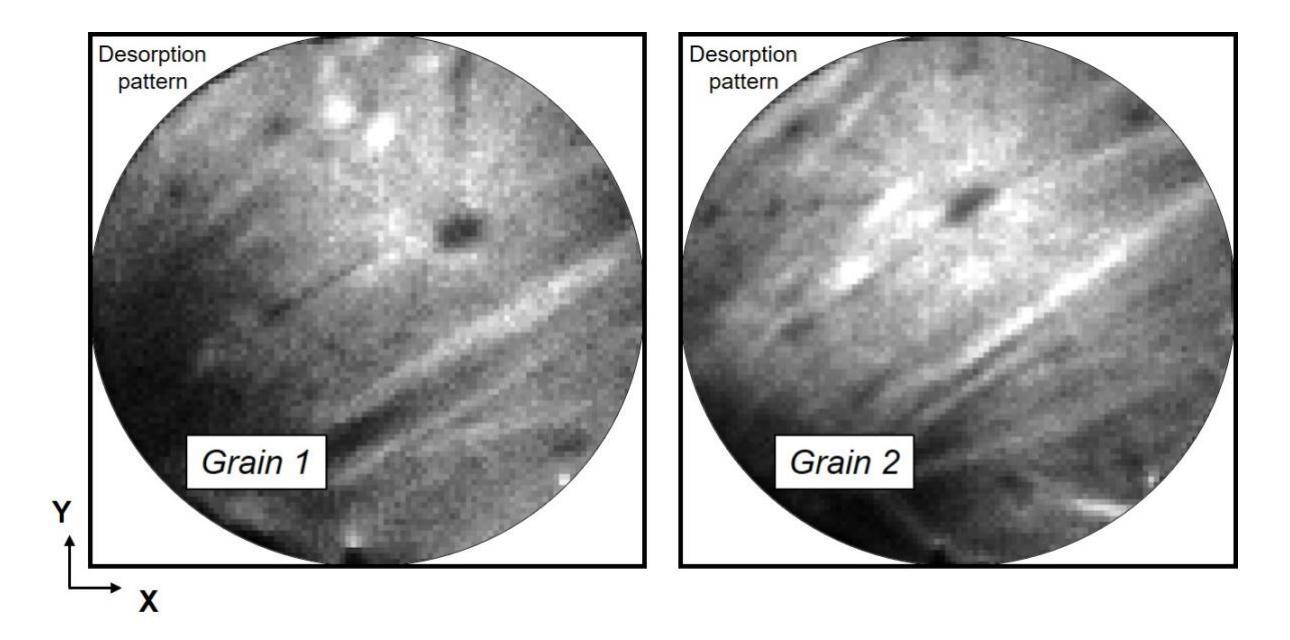
Figure S6. Desorption pattern showing two distinct crystallographic orientations within the crack tip (Figure 2b)

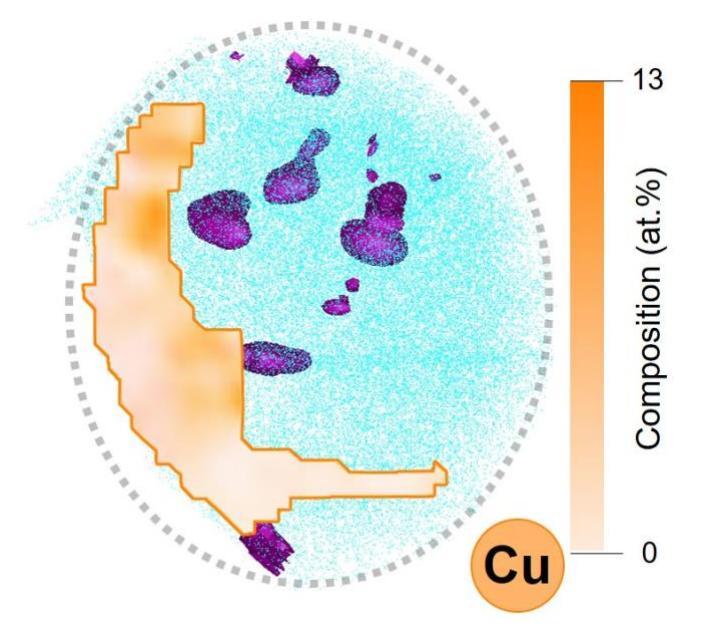
Figure S7. 2D Cu composition map, obtained from a 10 nm slice, showing the 2D elemental distribution of Cu in the oxide within the dotted-line slice shown in Figure 2b.
